INDOOR AIR QUALITY ASSESSMENT

**Registry of Motor Vehicles
4 Summer Street
Haverhill, Massachusetts**

Prepared by:
Massachusetts Department of Public Health
Bureau of Environmental Health
Indoor Air Quality Program
March 2017

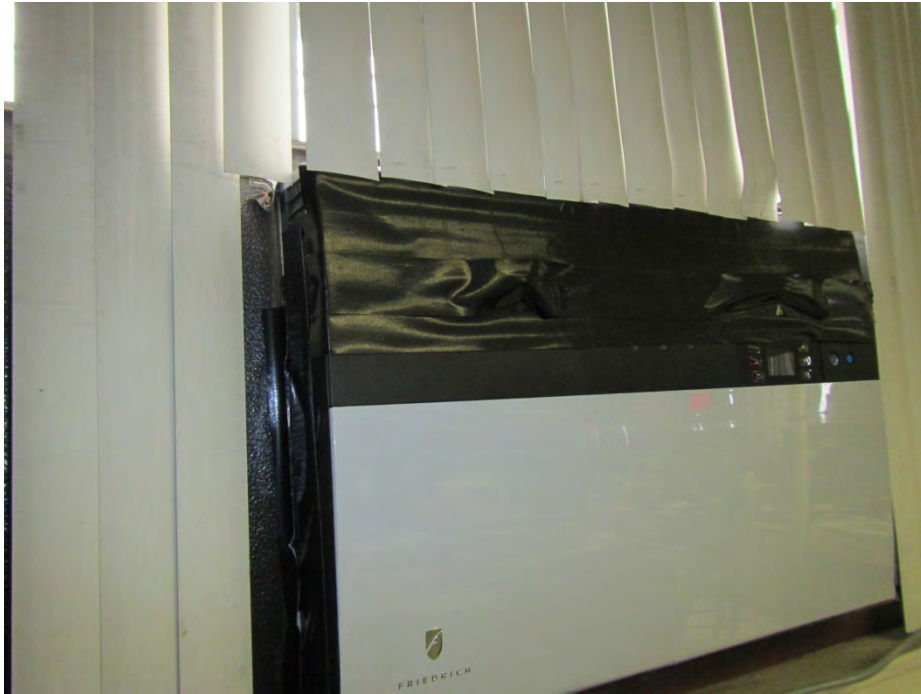
Picture 1

As previously mentioned, the RMV does have window AC units (Picture 1), which may be used to introduce fresh air when operated during the “fan only” mode during temperate weather. One AC unit was operating during this assessment; the other two units were taped over to prevent winter drafts. Without adequate fresh air exchange, normally occurring pollutants cannot be diluted or removed, causing them to build up and lead to IAQ/comfort complaints.

Window-mounted air conditioning unit (note tape over air vents)

4. Consider consulting with an HVAC contractor to improve fresh air exchange in the space. In the meanwhile, window AC units can be utilized in "fan only" mode to bring in more fresh air during temperate weather.

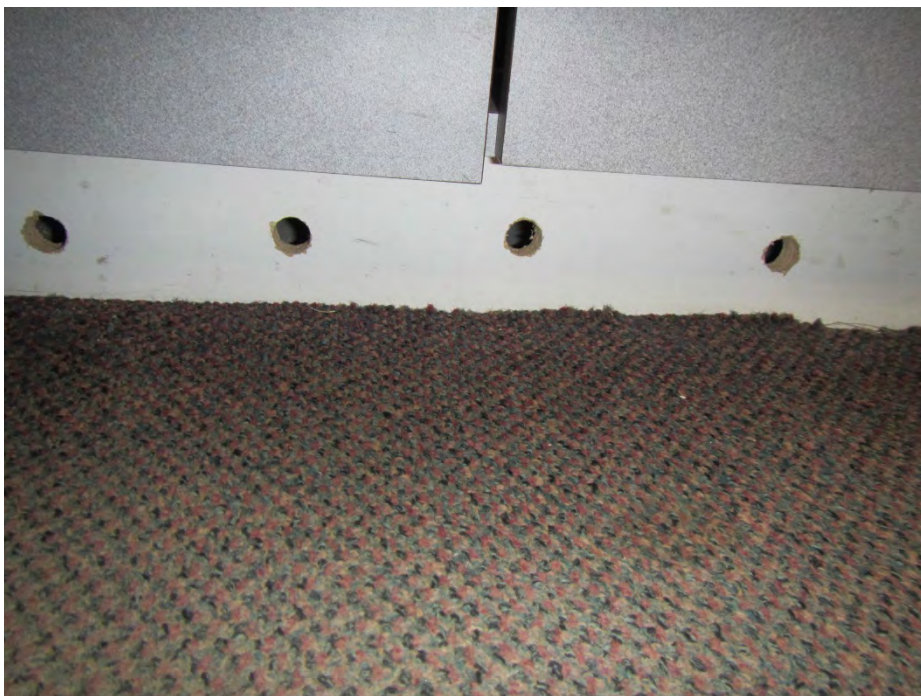
Picture 2

As mentioned, the assessment was prompted by concerns related to a steam pipe rupture that occurred on Friday, February 12th, 2017. According to reports, approximately two-inches of water had accumulated in the space. Occupants reported that Haverhill City officials began extracting accumulated water soon after the pipe burst Friday evening. The RMV contracted with flood remediation contractor, Belfor Property Restoration, who arrived on Saturday and began remediation actions. Belfor deployed fans, dehumidifiers, and air scrubbers in their remediation efforts. They also removed stored items, removed base coving and drilled holes in walls/floor boards (Picture 2) where access was restricted. It should be noted that the majority of building

Holes drilled in desk floor board to accelerate drying

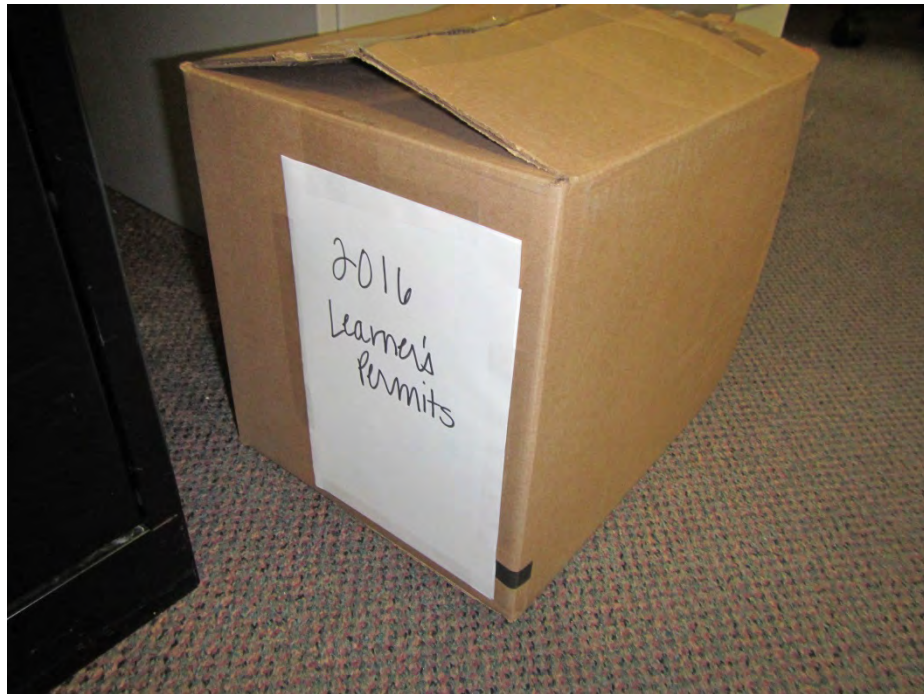
Picture 3

BEH/IAQ staff noted a box of learner's permits (Picture 3) that remained moist and brought this to the attention of the RMV manager. Using a moisture meter, BEH/IAQ staff noted that all carpeting and other porous items tested were found to be dry at the time of the assessment. In general, boxes and stored papers should be stored on shelving and not directly on the ground especially in a basement location where condensation can damage these porous items.

Box of permits found to be moist during assessment

1. Remove the box of 2016 learner's permits that was found to be still moist during the assessment. Remove and discard any other porous materials that are found to be moist beyond the EPA recommended 24-48 hour drying period. These records may be scanned or copied prior to discarding.

7. Do not store cardboard boxes directly on floors; store on shelving/off the ground to prevent moistening/mold growth.
8. Relocate or consider reducing the amount of stored materials in offices to allow for more thorough cleaning. Move items from floors when possible. Clean items regularly with a wet cloth or sponge to prevent excessive dust build-up. Consider coordinating between staff and maintenance personnel to conduct quarterly clean-up activities.

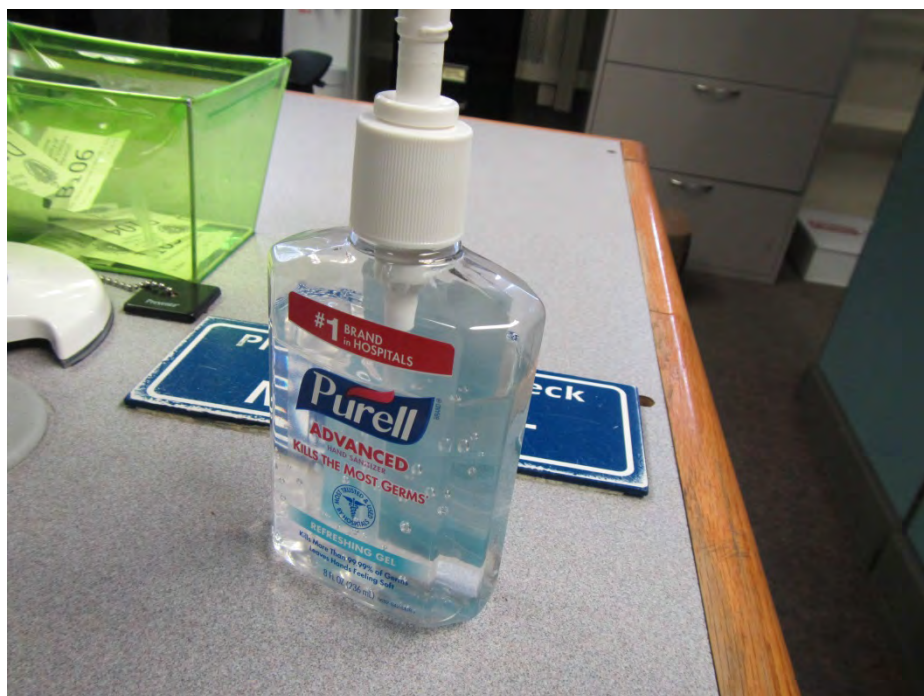
Picture 4

Hand sanitizers, air deodorizers, and cleaning products were observed in several areas (Picture 4). Hand sanitizer products may contain ethyl alcohol and/or isopropyl alcohol, which are highly volatile and may be irritating to the eyes and nose. Deodorizers contain chemicals/fragrances to which some people may be sensitive.

Hand sanitizer containing fragrances

9. Reduce the use of products containing VOCs/fragrances (e.g., hand sanitizers, air deodorizers, and harsh cleaning products).
10. Clean carpeting annually or semi-annually in soiled high traffic areas as per the recommendations of the Institute of Inspection, Cleaning, and Restoration Certification (IICRC, 2012). Consider replacing carpeting that is past its useful service life. When

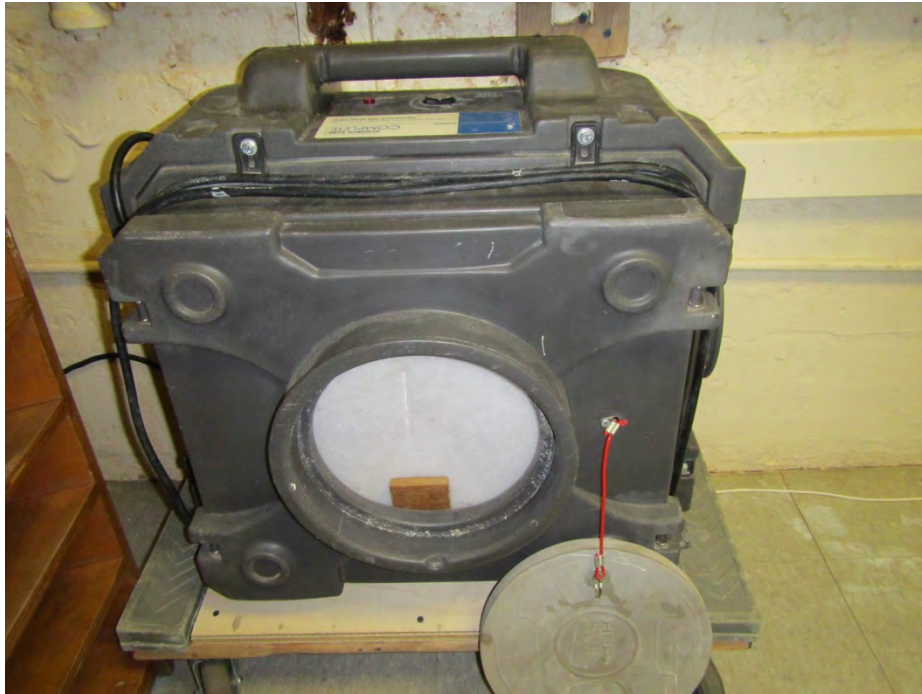
Picture 5

Belfor deployed a high efficiency particulate air filter (HEPA) air scrubber (Picture 5) that apparently also contained a deodorizing agent to help with complaints from occupants regarding a "chemical" odor. The odor reportedly was due to the repair of the steam pipe that had burst. Pipe repair sealant (Picture 6) was the likely source of this initial odor since it may contain

solvents that evaporate at room temperature. BEH/IAQ staff did not detect any solvent odor at the time of the assessment but did detect a strong cherry deodorizer odor. BEH/IAQ staff received several complaints regarding the strong deodorizing odor during the assessment. Typically, a HEPA scrubber is useful in filtering out small particulate matter but unless it also contains an activated carbon filter it will only mask any solvents with an added fragrance. It was not known at the time of the assessment if the air scrubber was also fitted with a carbon filter to absorb TVOCs rather than just mask them.

HEPA air scrubber located in area of pipe burst

2. Remove deodorizing agent from air scrubber or entire scrubber from the space due to the complaints received from the strong fragrance which can have irritant effects.

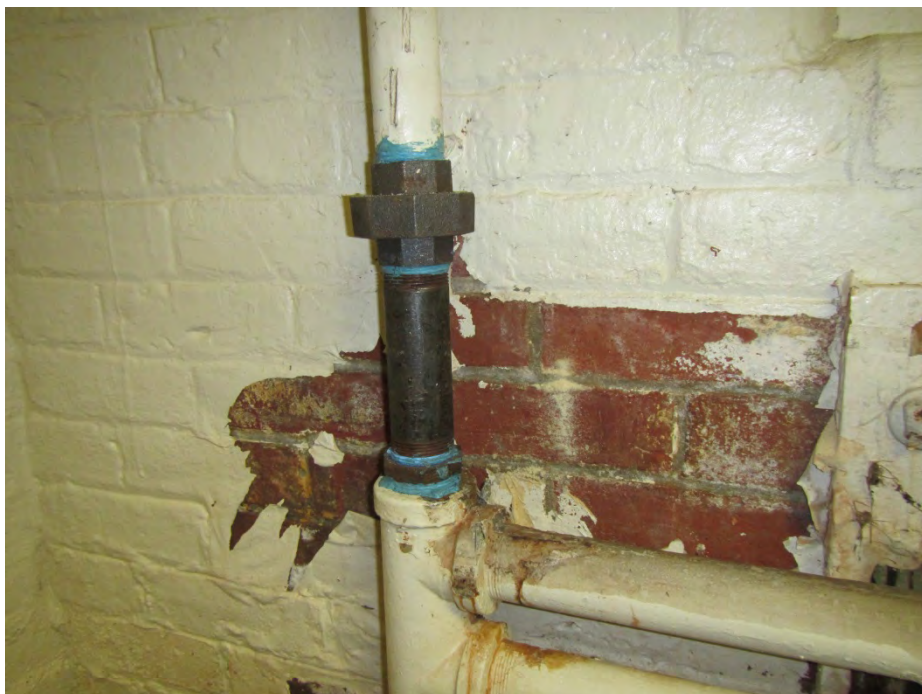
Picture 6

BEH/IAQ staff noted the presence of loose and peeling paint in the area of the steam pipe burst (Picture 6). Some occupants expressed concerns about this condition. Given the age of the building, any repairs made to this paint should be performed during unoccupied hours and utilize lead safe remediation practices.

Steam pipe repair (new black pipe); note blue pipe dope

3. Inspect area of loose/peeling paint in area of pipe burst. Any repairs made to this paint should be performed during unoccupied hours and utilize lead safe remediation practices.

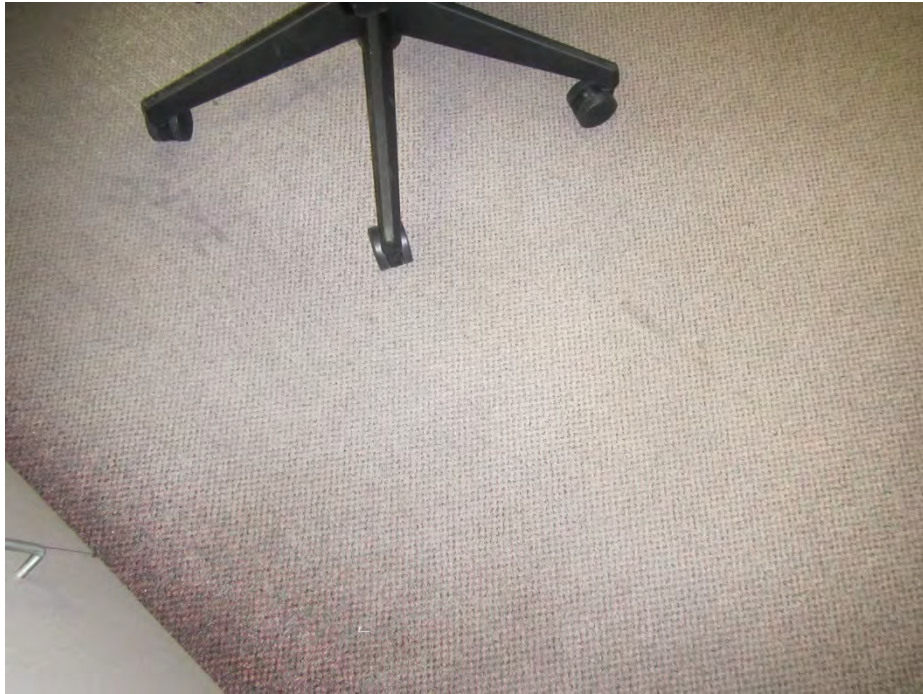
Picture 7

Other conditions that can affect IAQ were observed during the assessment. A small area in the office is carpeted; the Institute of Inspection, Cleaning, and Restoration Certification (IICRC), recommends that carpeting be cleaned annually (or semi-annually in soiled high traffic areas) (IICRC, 2012). As mentioned this carpeting was tested and found to be dry at the time of the assessment but it also appeared to be worn and past its useful life (Picture 7). In general, carpeting is not recommended in basement areas especially if exposed to chronic moisture. Since the average lifespan of carpeting is approximately eleven years (Bishop, 2002), consideration should be given to planning for the installation of new flooring.

Area of worn carpeting

choosing a new flooring material, remember that in general, carpeting is not recommended for below grade spaces.
